B-HCE Report Number 44-22003 – Pendant Properties, LLC Attachments

Photograph 79

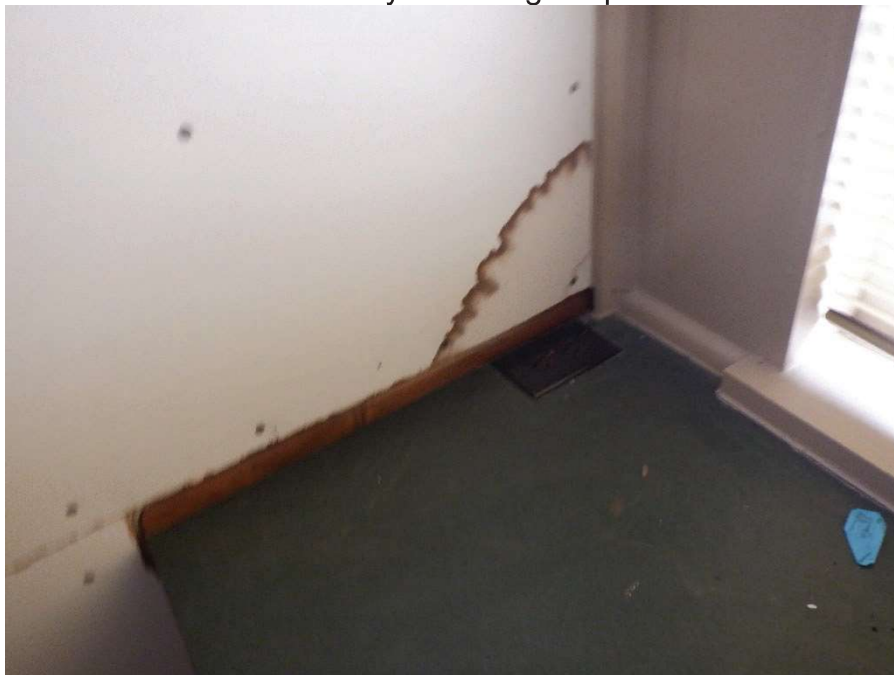
View of the water stains to the drywall along the perimeter wall in suite 616.

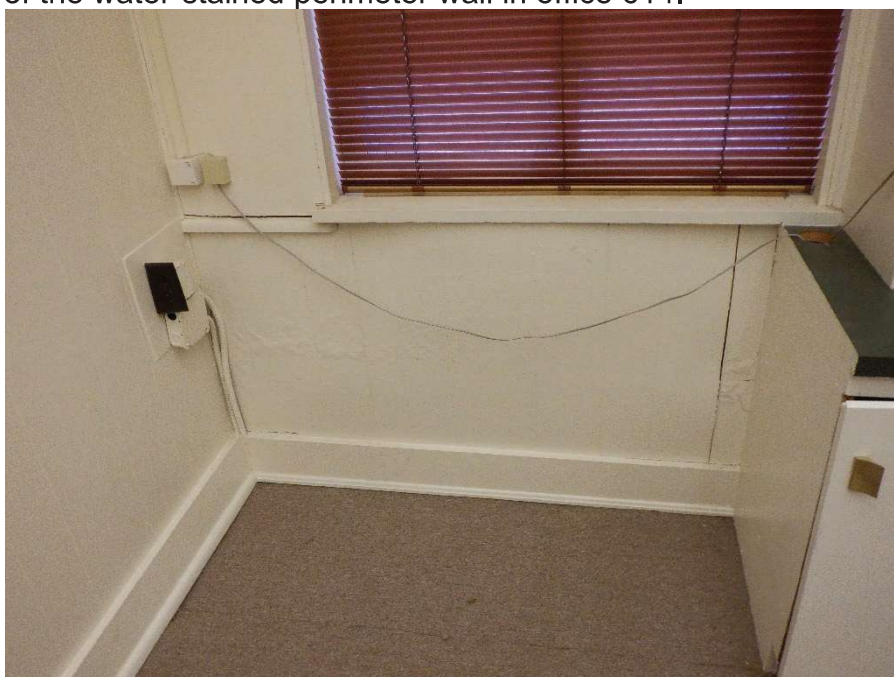
B-HCE Report Number 44-22003 – Pendant Properties, LLC Attachments

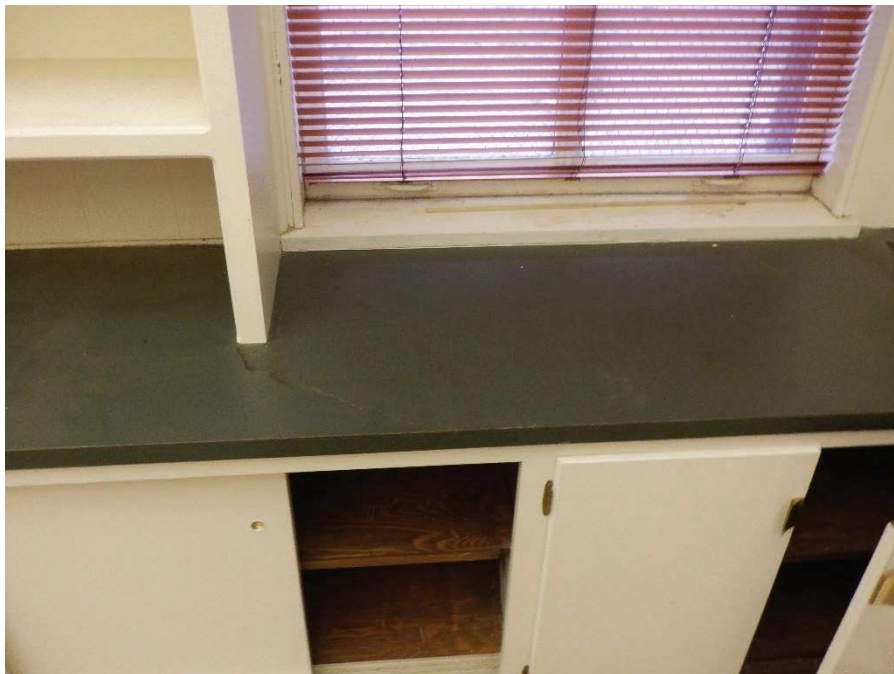
View of the water-damaged perimeter wall paneling and over the desk in office 614.

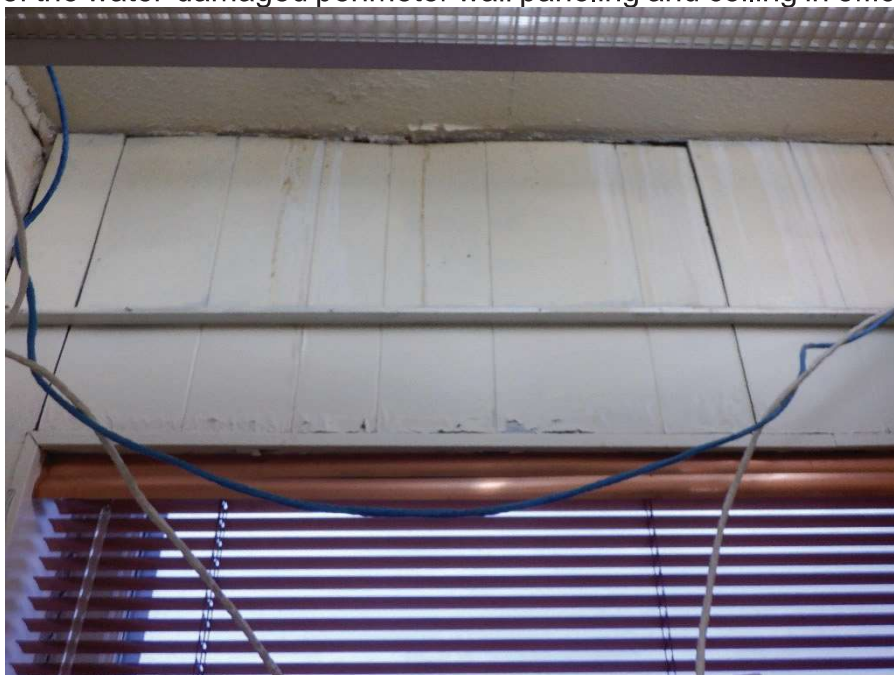
B-HCE Report Number 44-22003 – Pendant Properties, LLC Attachments

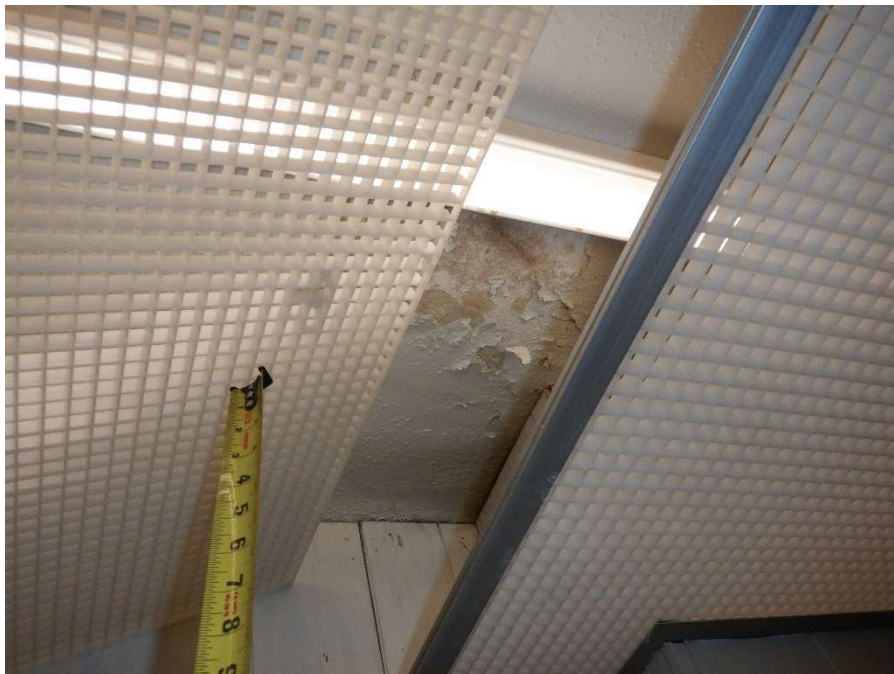
View of the water-damaged perimeter wall paneling and ceiling finish in office 619.

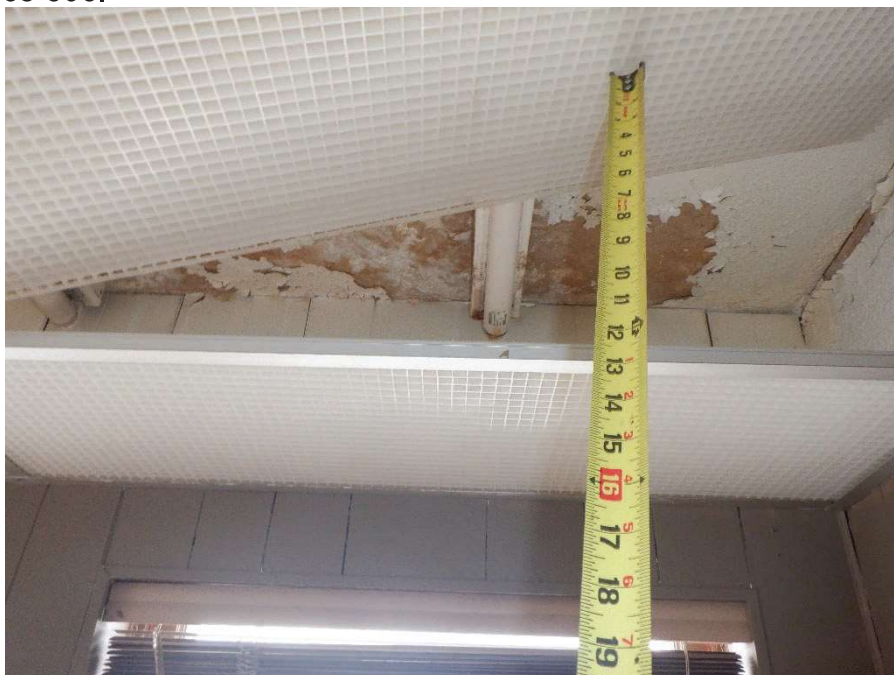
B-HCE Report Number 44-22003 – Pendant Properties, LLC Attachments

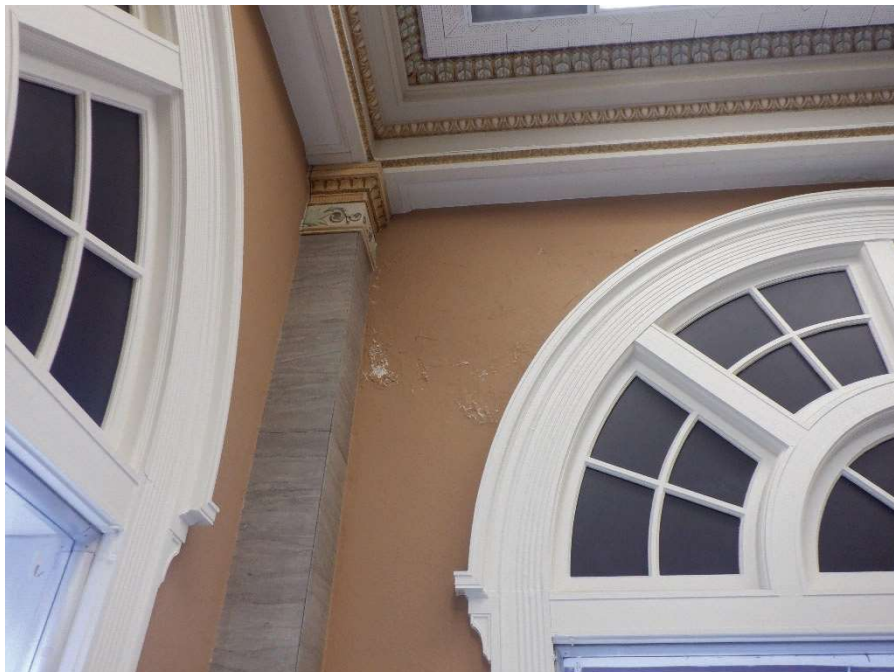
View of the water damaged finishes in the northwest perimeter corner of the bank.

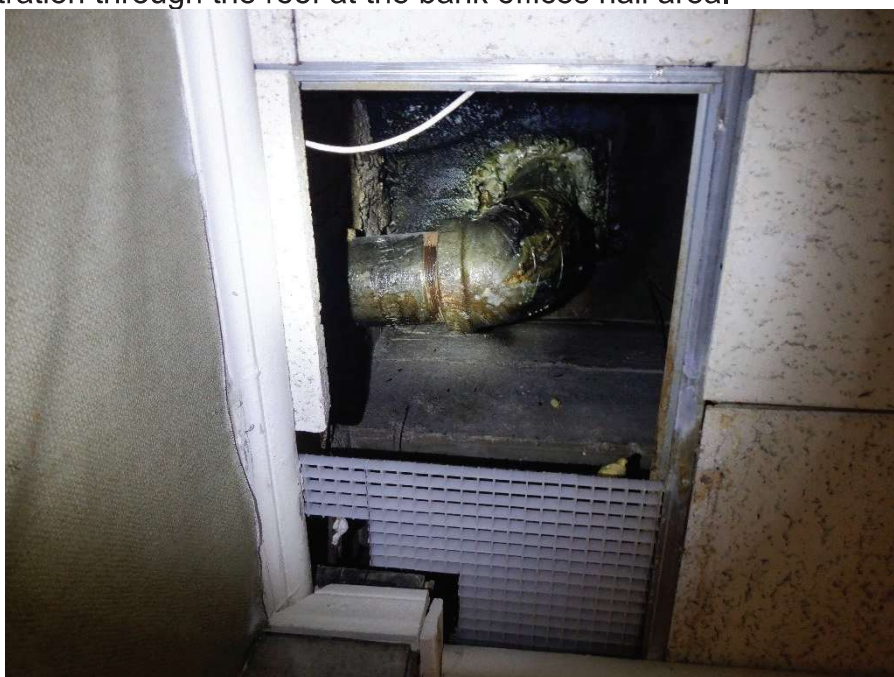
B-HCE Report Number 44-22003 – Pendant Properties, LLC Attachments

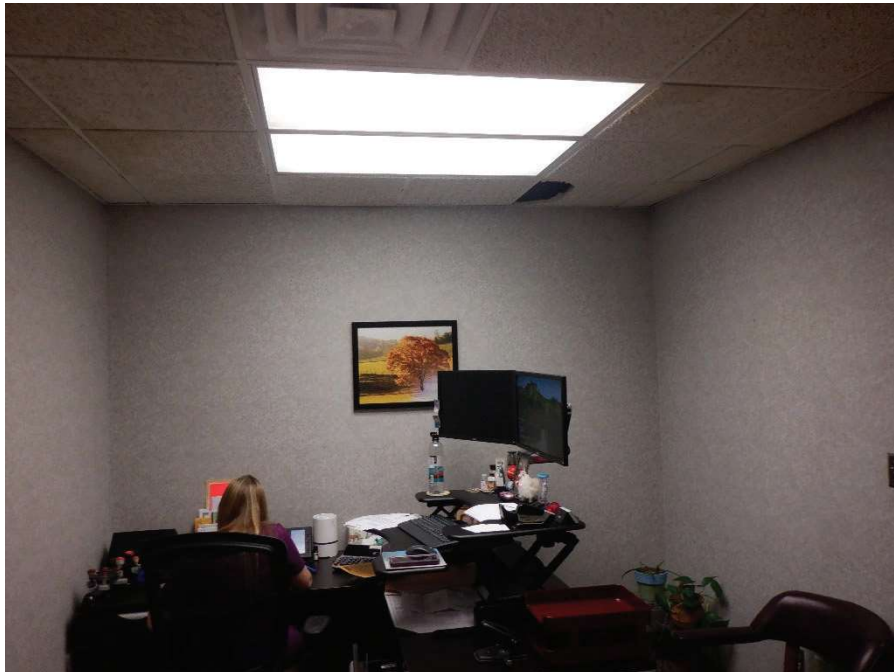
View of the water-stained and partially missing ceiling tiles over a bank office area.

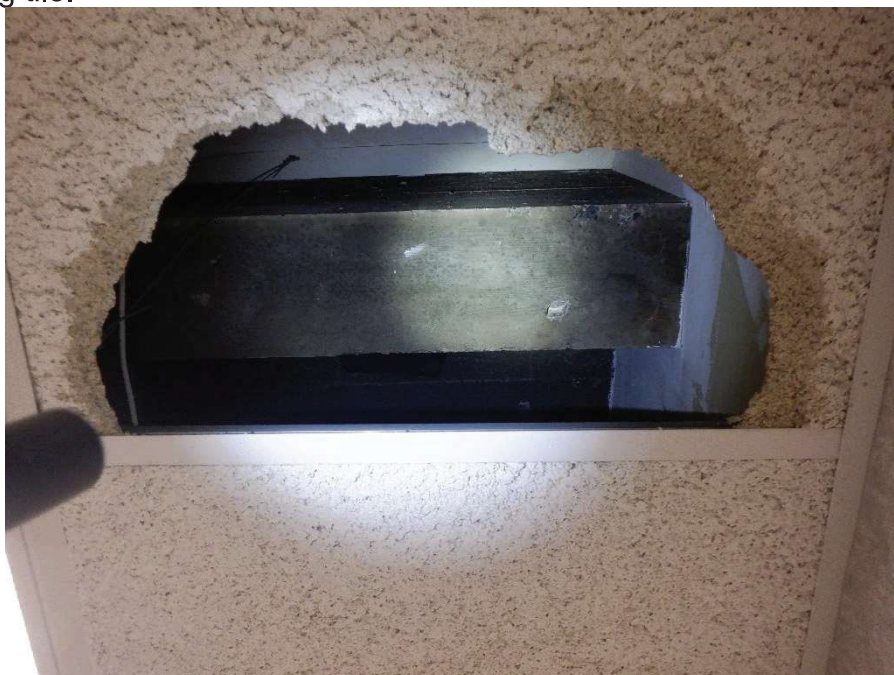
**B-HCE Report Number 44-22003 – Pendant Properties, LLC
Attachments**

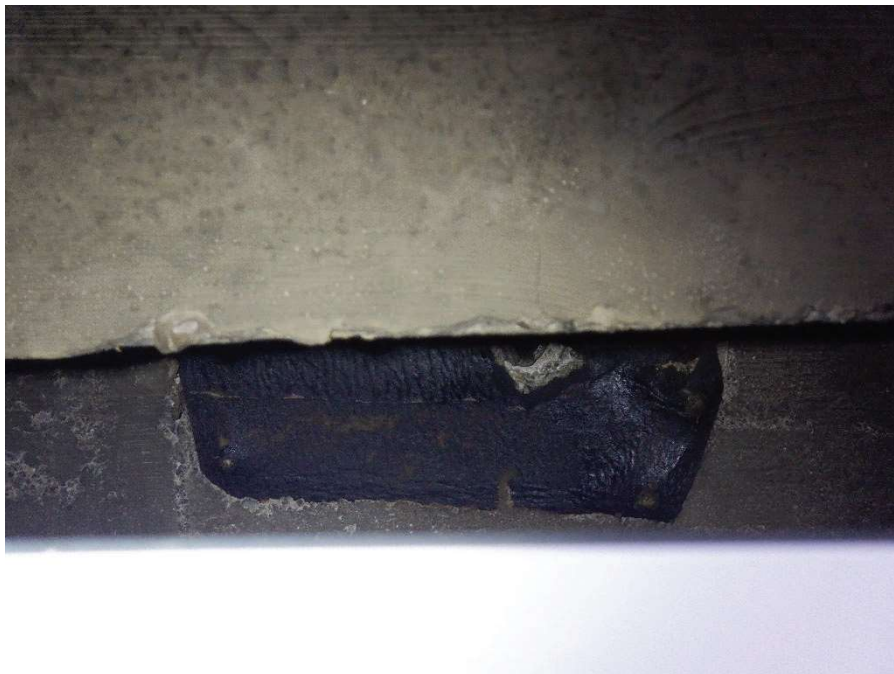
View of a roof deck penetration above the partially missing ceiling tile in the bank office.

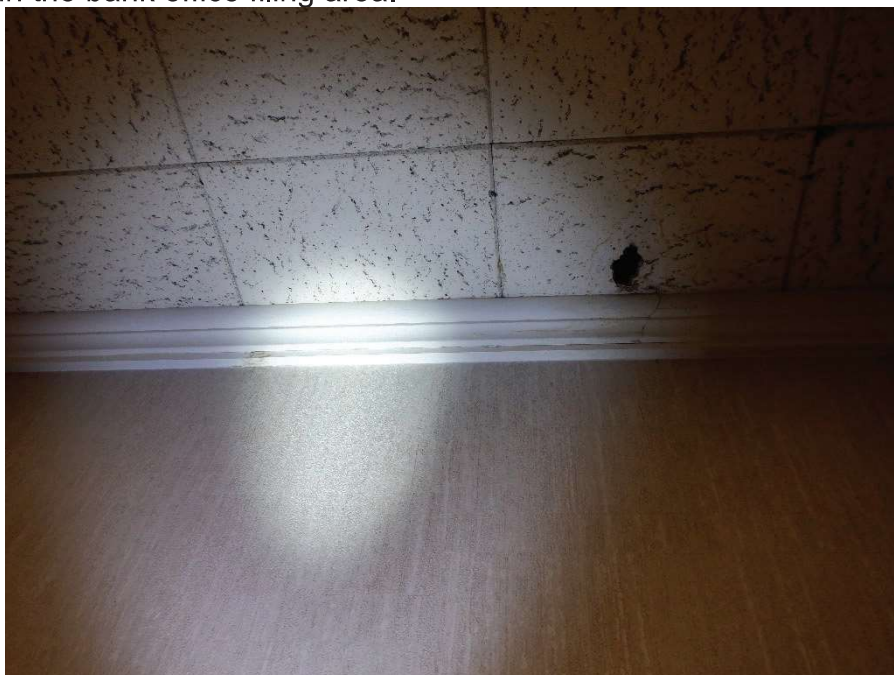
B-HCE Report Number 44-22003 – Pendant Properties, LLC Attachments

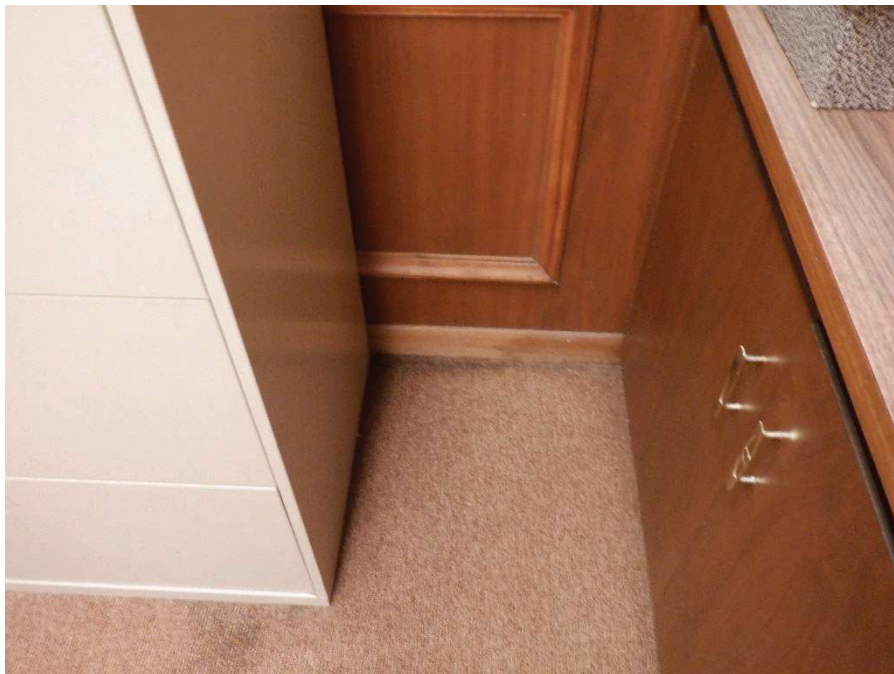
View of the water-stained base trim and floor coverings in the bank office area.

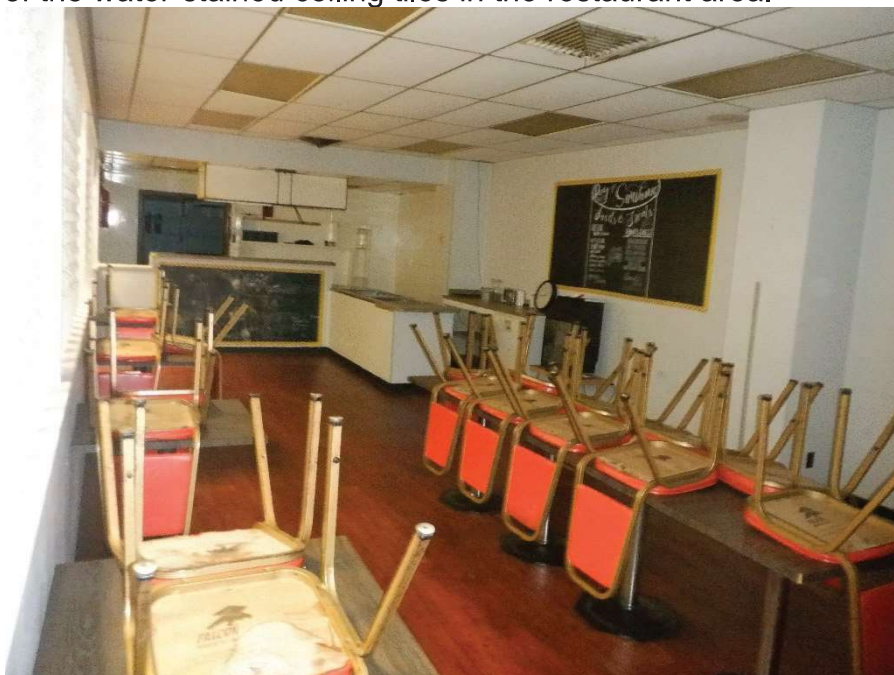
View of the water-stained ceiling tiles in the restaurant area.
